## A Coastal Microburst Wind Damage Survey and Observations

M.J. Glanville<sup>1</sup> and N.A. Moir<sup>2</sup>

### ABSTRACT

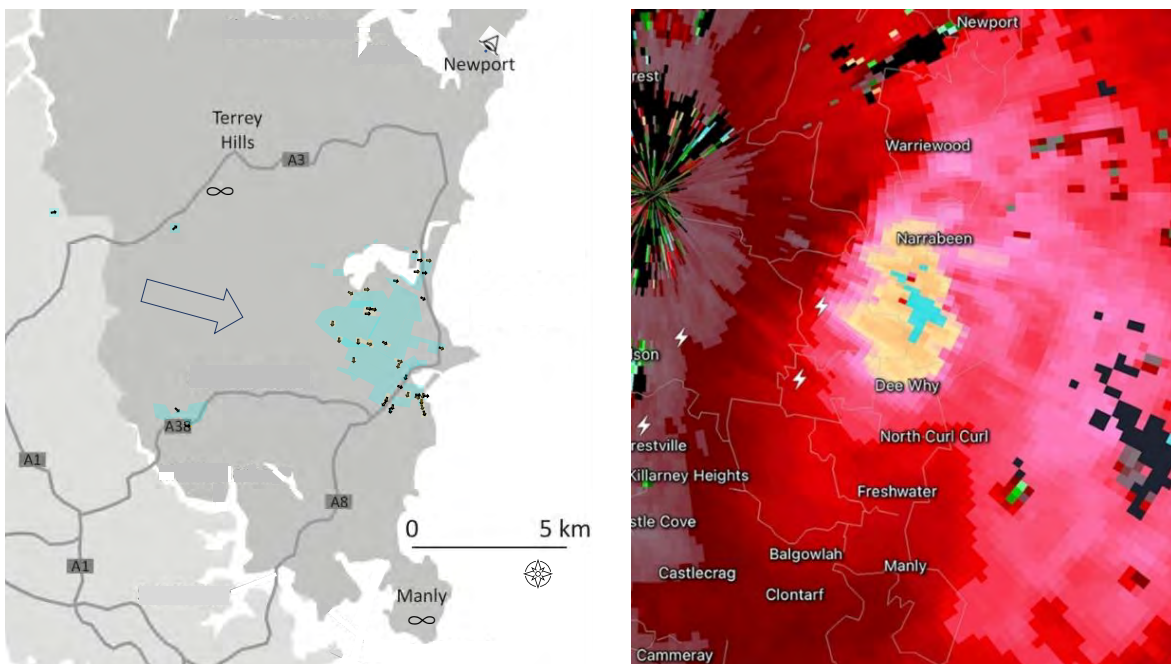
Figure 1. Sighted storm damage locations on Sydney Northern Beaches (L). Bureau of Meteorology via RadarScope velocity doppler radar image 15:34 19<sup>th</sup> December 2021 (R).

A series of thunderstorms formed over the Northern Beaches initially causing localised damage at Forestville before forming a microburst over Narrabeen lagoon. Rapid intensification is observed around 15:34 in velocity doppler images of Figure 1 with exceedance of the Terry Hills Nyquist velocity 94 km/hr.

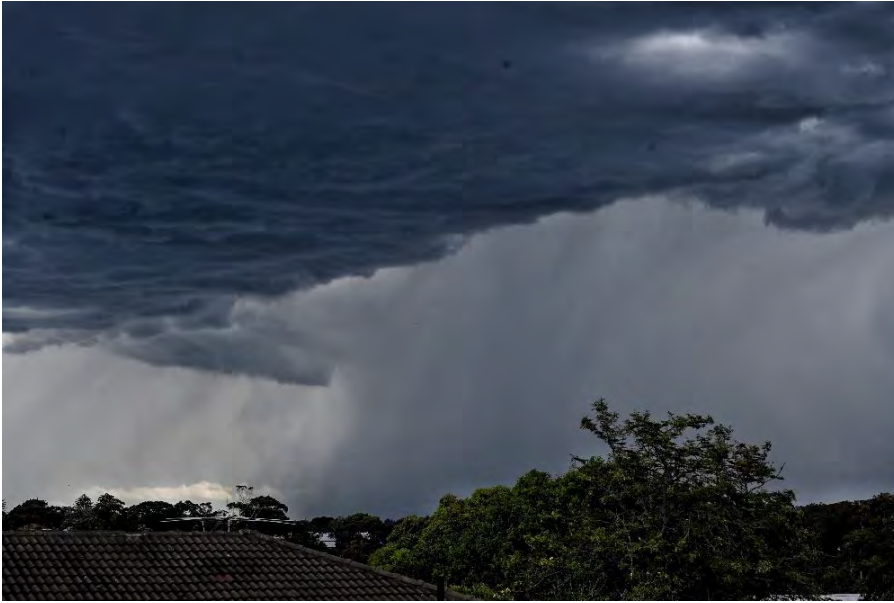
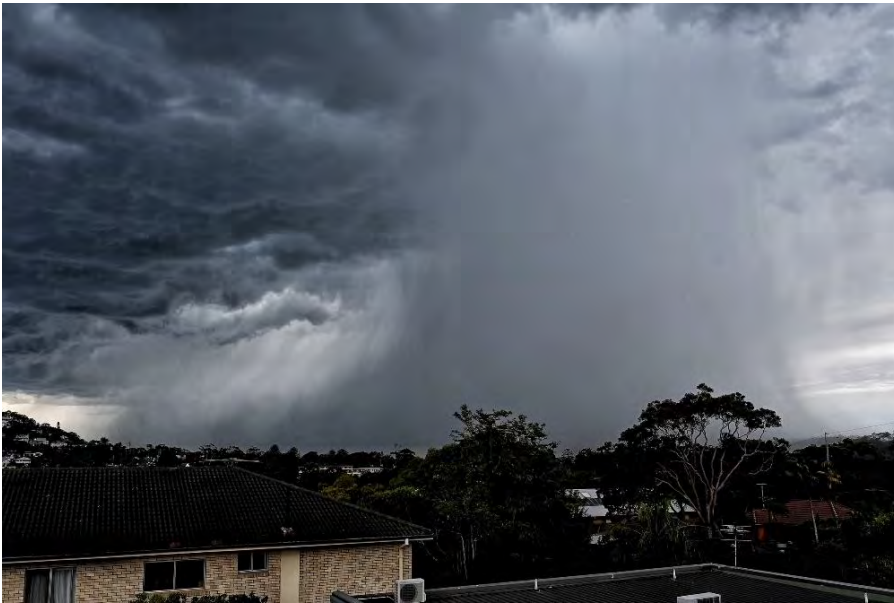
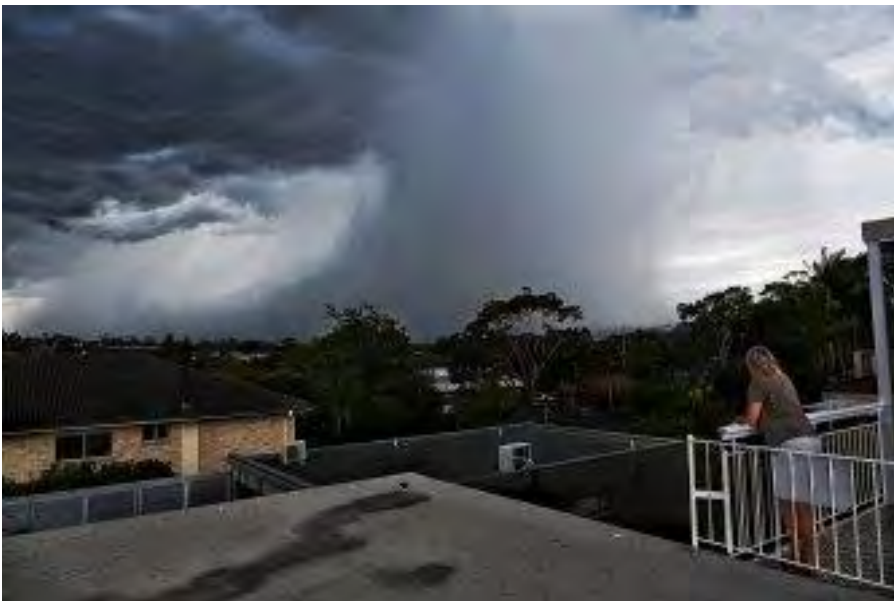
Figure 2. Narrabeen Lagoon microburst photographed from Newport by Moir<sup>2</sup> 19<sup>th</sup> December 2021

The Narrabeen Lagoon microburst was captured in a sequence of photographs by Moir<sup>2</sup> taken from an apartment building rooftop in Newport, Figure 2. At 15:25 air in the vicinity of Narrabeen Lagoon is seen to updraft into the string flat base to the shelf cloud on the left side of the photo. Evaporation of rain falling into the dry cold front air (centre photo) further cools and increases air density thereby accelerating the downdraft vertically resulting in the microburst seen at 15:33 and 15:34, with outflow moving toward the left (note photo viewing angle in Figure 1).

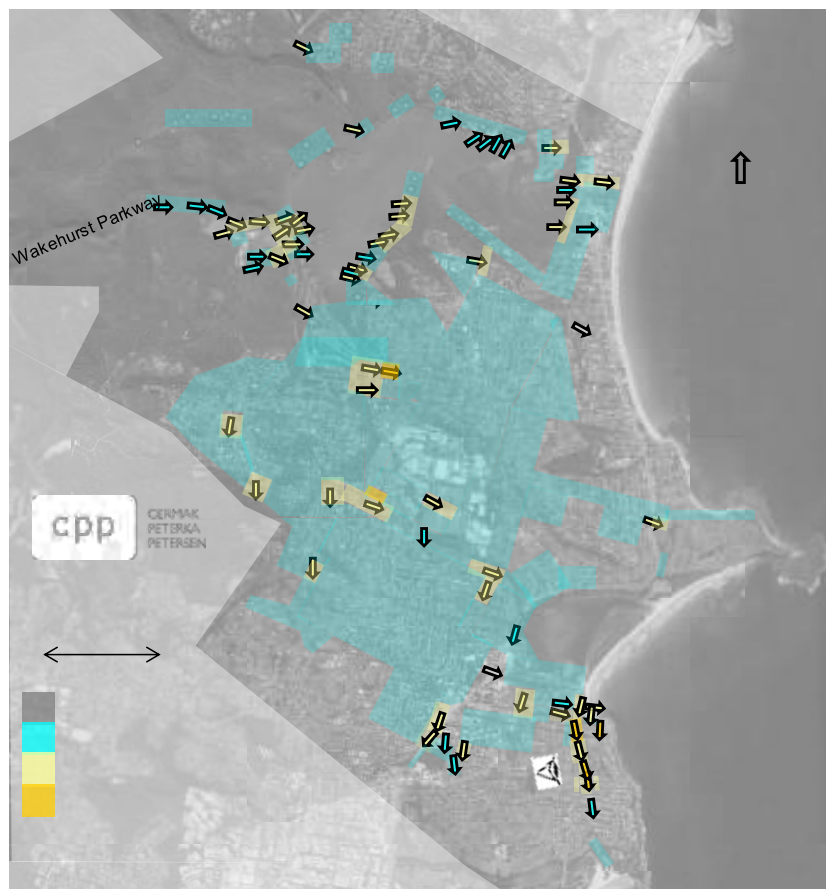
Figure 3. Estimated EF-scale damage ratings assigned to surveyed buildings and natural environment.

Figure 3 maps all observed damage rated against the EF-scale. Damage generally being assigned an EF0 or EF1 rating, and some isolated EF2 damage. Most EF0 damage evidence was medium to large branches snapped off large trees and EF1 small to large trees snapped or uprooted; the fallen trunks providing an indication of wind direction. Several roofs were blown from homes and apartments indicative of EF2 damage, e.g., Figure 5.

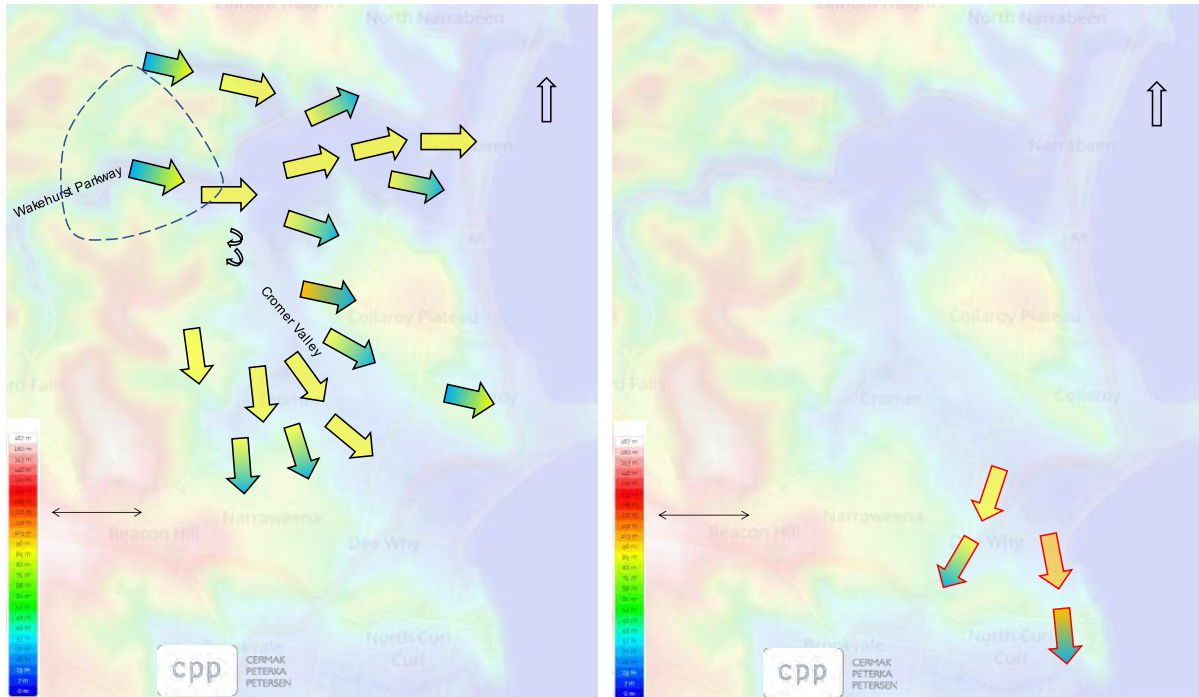
Topographic contours (sea level to 170m) are overlaid in Figure 4 with larger arrows providing an interpretation based on the study observations and photographs above. The initial microburst appears to have occurred with a stagnation point to the west of Narrabeen Lagoon in the reserve and over the Wakehurst Parkway valley, with an approximate initial footprint shown by the broken line.

Terrain was observed to play a primary role in the spread of the outflow. In 'Stage 1' the outflow appears to sink immediately into the Wakehurst Parkway and Narrabeen Sports Centre valley with the cold heavy high velocity flow staying below about 70m terrain height as evidenced by tree damage; buoyancy appearing to govern the outflow pattern. The outflow then appears to split in two directions; one path continuing over Narrabeen Lagoon and the other into the Cromer valley toward Dee Why.

Figure 4: Flow interpretation from photos and survey damage overlaid on topographic contours.

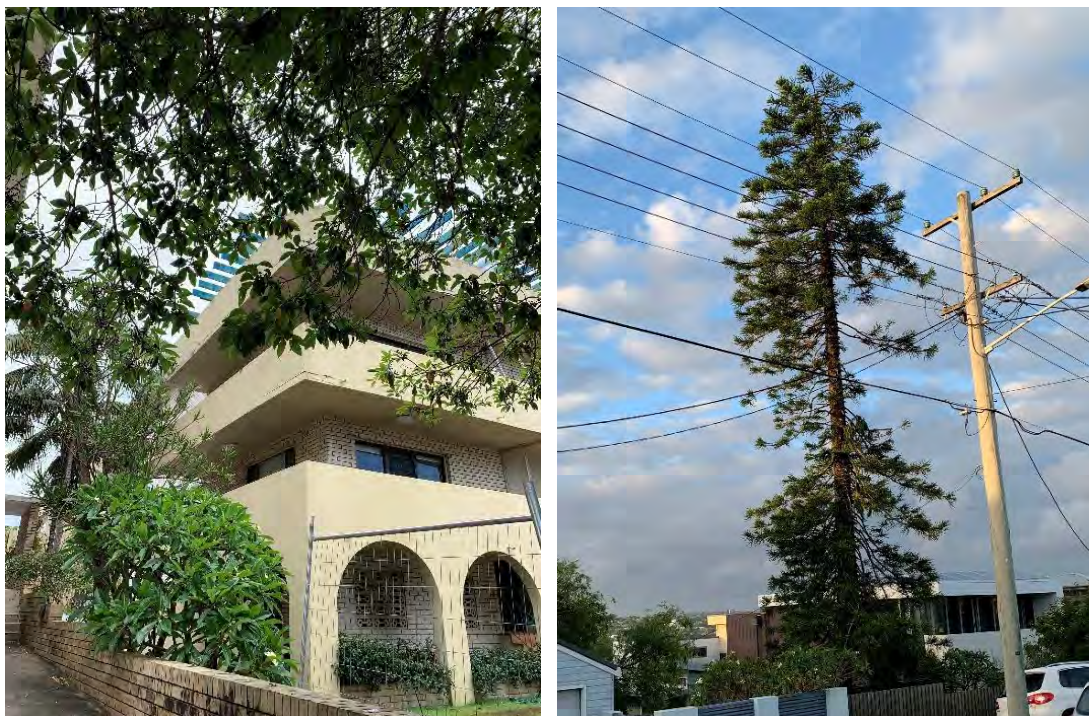
Part of the initial Dee Why outflow is channeled between buildings lining The Strand to the south before lifting the roof from a 4-storey unit block on Pacific Parade as captured in video footage contained in the Northern Beaches Advocate (2021). Analysis of video footage approximates roof height wind speed in the order 40-50 m/s yet undisturbed gardens at ground level of the same building are seen in Figure 5. This suggests a localised jet nature to the outflow with minimal turbulence mixing at ground level. Roof debris was carried directly downstream with the rain laden outflow in a SSE direction causing some projectile impact damage to property.

Figure 5: Unit block on Pacific Pde lost its roof yet suffered no damage at ground level (L). Branches snapped from the central 1/3 of a Norfolk Island Pine (R).

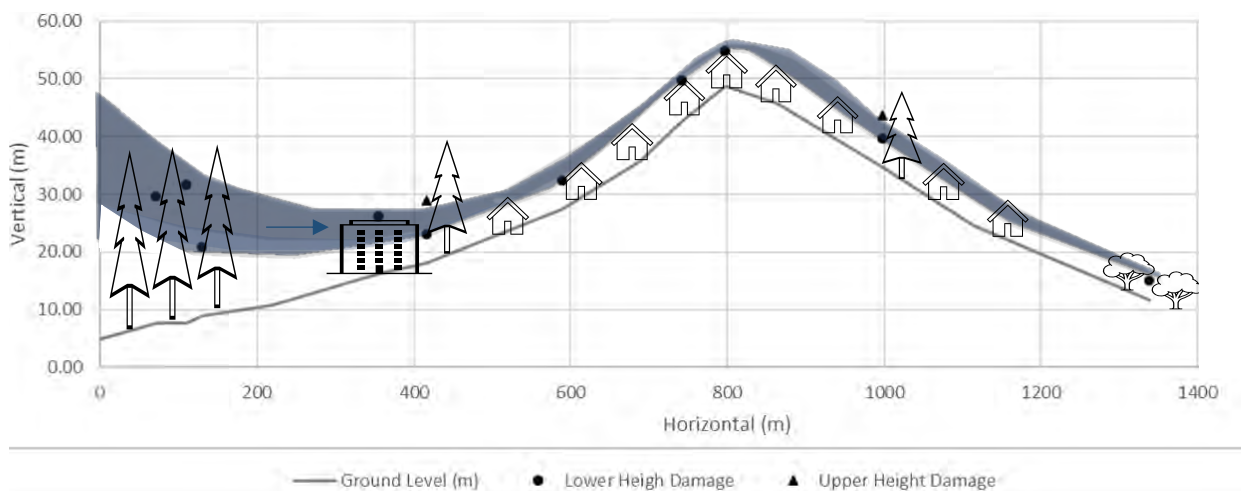
A vertical profile of observed damage over the Dee Why headland is mapped indicatively in Figure 6 based on the damage survey (note profile viewing angle in Figure 3). Branches snapped from several Norfolk Island Pine species provided in some cases a lower and upper bound to observed damage and supported a jet velocity profile hypothesis, Figure 5. The thin ribbon of outflow continued over the Dee Why headland then sunk downhill toward North Curl Curl Beach. Similar outflow characteristics can be observed in other media video footage of the event, e.g. Ralph (2021).

Figure 6: Estimated vertical outflow profile over the Dee Why headland based on damage survey.
