Tornadic Waterspout Impacts on Coastal Australia

M.J. Glanville¹, C.J. Rohr¹ and J.D. Holmes¹

¹Cermak Peterka Petersen Pty Ltd,

Surveyed damage using the Enhanced Fujita Scale is presented for a recent tornadic waterspout event at Kurnell in NSW.

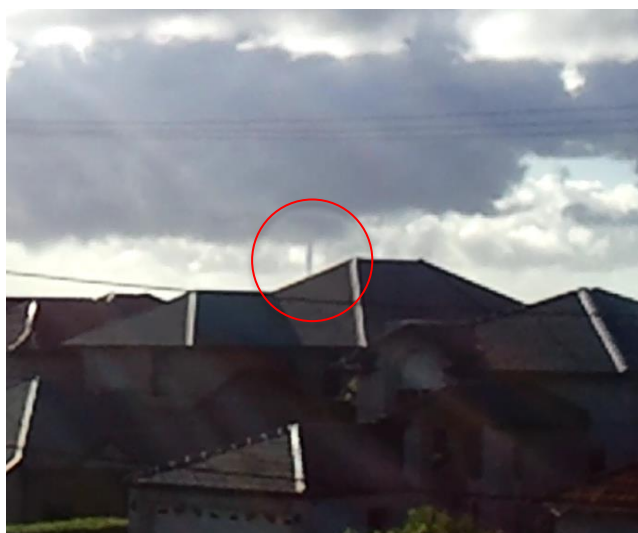
Figure 1: Fair weather waterspout sighted by first author off the coast of North Curl Curl, Sydney (2013).

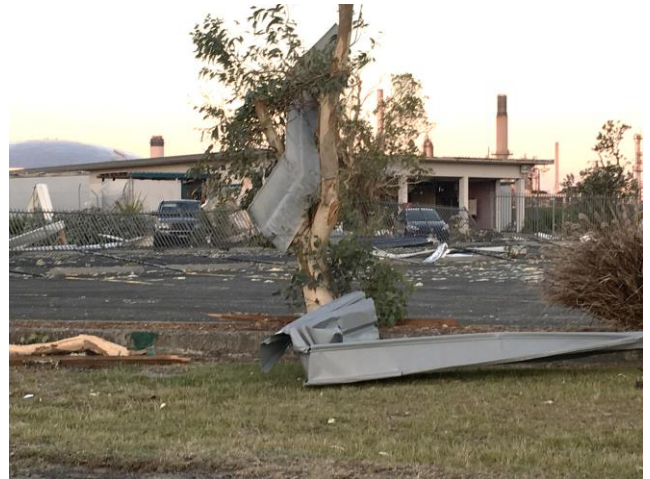
Much of Sir Joseph Banks Drive was littered with debris from this and other buildings (Figures 4).

Figure 4: Debris from the desalination plant and other surrounding buildings on Sir Joseph Banks Drive, Kurnell.

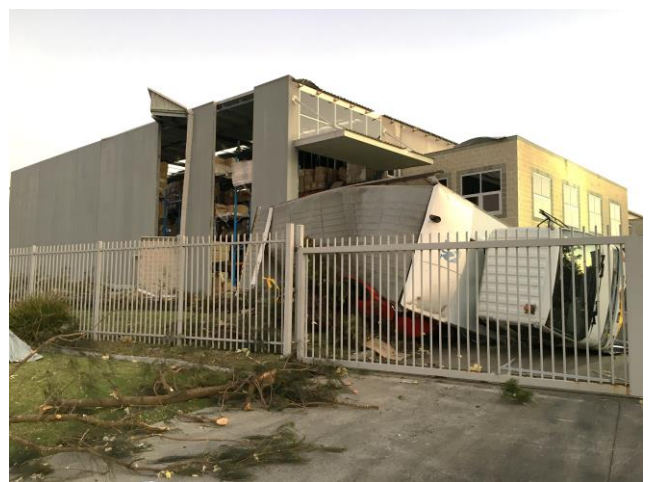
Industrial units in the direct path suffered façade breaches including broken windows and lifted roof sheeting. On Chisholm Road a lorry was blown over onto an adjacent and thankfully empty parked car (Figure 5). As the tornado continued northwards crossing Captain Cook Drive it passed over roadside high voltage transmission lines, but no damage was evident to these structures. Similarly, no obvious damage could be sighted to the refinery east of Captain Cook Drive.

Figure 5 Damage to industrial building on Chisholm Road, Kurnell, with overturned truck in foreground.

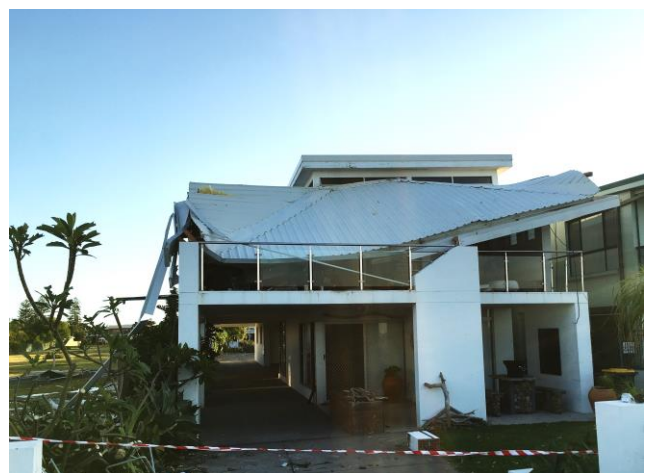
The tornado passed directly over the residential township of Kurnell northward to Botany Bay, Figure 6. Inspecting damage in the residential zone was reminiscent of surveying water spout damage in Lennox Head 2010, with damage confined to a finite width outside of which little permanent damage could be observed. Roof damage was common to homes in the damage swathe, with lifted roof sheeting, and missing tiles, and removed solar panels.

Figure 6: Damage to a residential home in the Kurnell township.

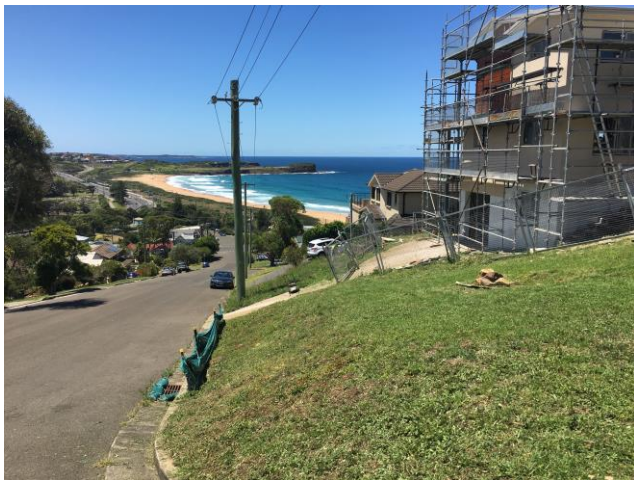
Property damage at Kiama was similar to that in the Kurnell and Lennox Head events, based on media reports and verbal discussions with Kiama residents by the first author. Figure 7 illustrates a home re-build still in construction almost three years after the event. The waterspout was reported to have come off the ocean causing damage to properties on the hill crest (camera location) before continuing south then inland toward Jamberoo.

Figure 7: Hothersal Street, Kiama photo taken January 2016.
